Mosquito Creek Ravine East Bank Assessment

City of North Vancouver
141 14th Street
North Vancouver
B.C. V7M 1H9

Wednesday, July 19, 2006
Project #: 005-051

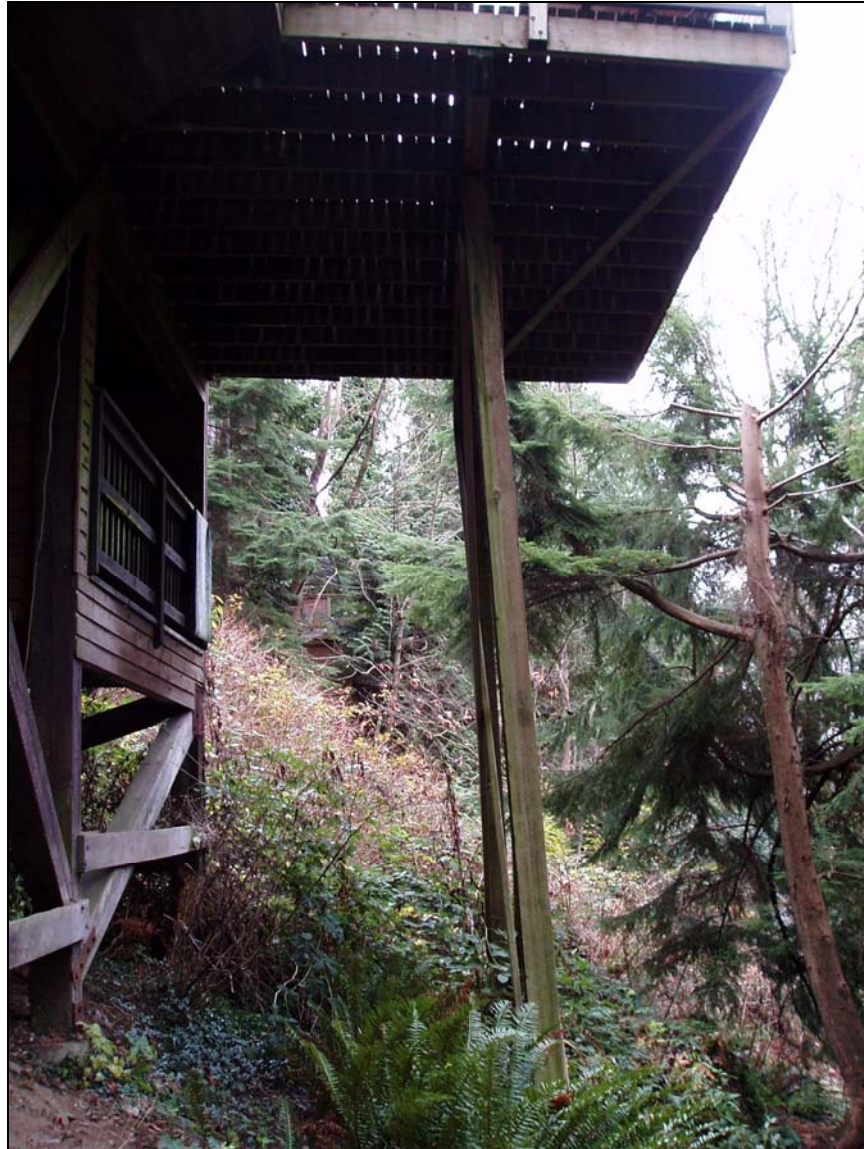
The houses at 2103 and 2101 Westview Drive are set back 3 to 5 m from the crest of the steep to very steep slopes. The deck posts at 2101 are founded at the crest of the slope and show signs of displacement, while the deck at 2103 is cantilevered from the main structure (refer to Plate 2). Geotechnical reports by CPD in 1976 and 1978 identified surficial fill over “native hard clayey silt” and recommended the footings bear on native soil. Constructed in 1978, the foundations were reportedly inspected by CABEL and are presumably founded on native soil.

Plate 2: Note the displacement of the post supporting the deck on this structure (thought to be at 2101 Westview Drive). The crest of the ravine is located next to the base of these posts. The BC Hydro RoW is in the background of the picture.

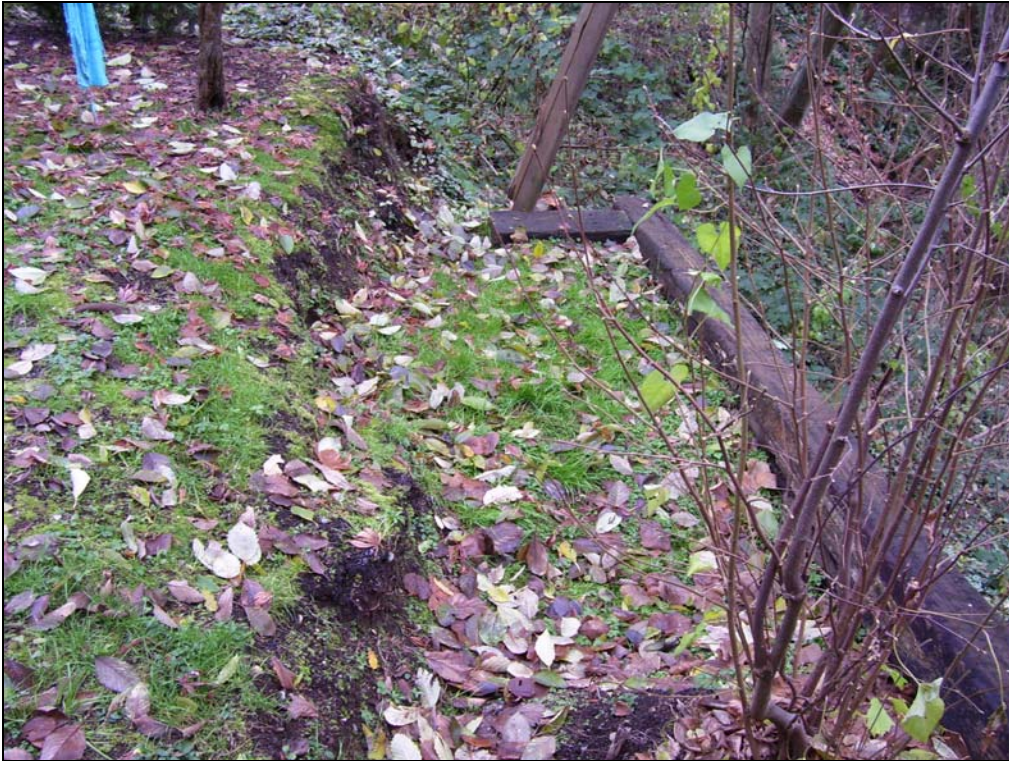
The house at 2017 Westview Drive is situated more than 10 m from the slope crest but the houses at 2015 and 2009 Westview Drive are closer to the slope. An old timber crib retaining wall at the slope crest next to 2015 Westview Drive supports sandy, organic fill placed in the backyard. This wall has settled and shifted forward at least 0.3 m creating a vertical scarp in the soil behind the wall (refer to Plate 3). The footings for the sundeck are setback approximately 7 m from the top of the retaining wall, while the house foundation is setback 10 m from the wall. The house at 2009 Westview Drive has a similar setback and neither house appears to have suffered damage due to the slope movement.

Plate 3: The separation behind the face of the retaining wall.

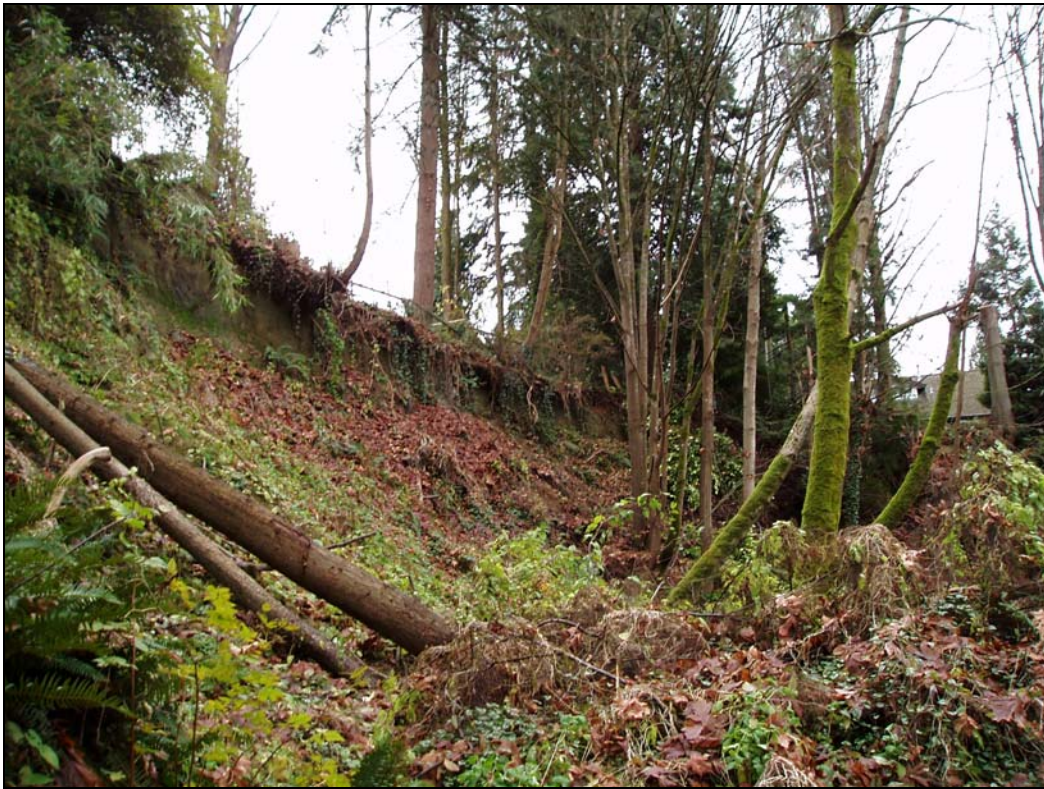
Plate 4: Looking at the scarp in a southeasterly direction. Note the debris pile in the foreground of the picture from the recent landslide at the north end of the scarp. The adjacent properties are 1931 to 1945 Westview Drive.

A recent, shallow landslide was noted on the northern edge of this scarp near 1945 Westview Drive. The runout from this event reached the gentle slopes at the base, near the trail.

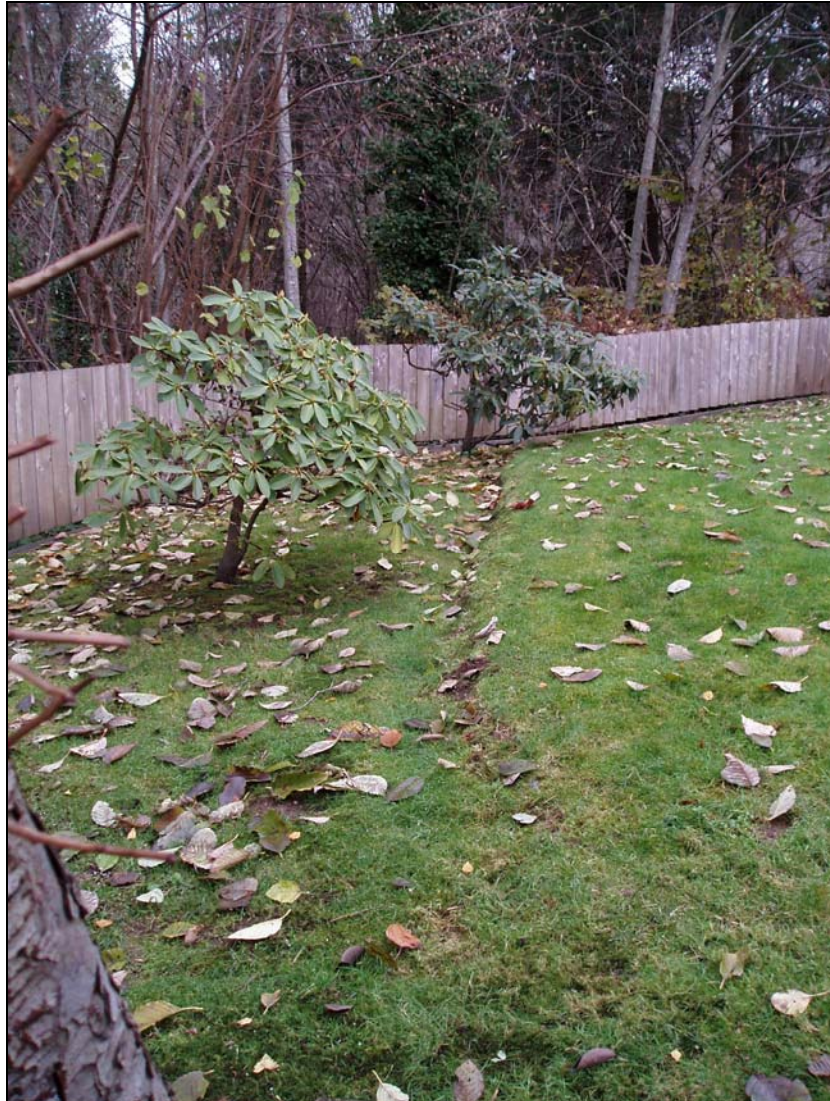
Plate 5: The tension crack and slumping fills at the rear of the lots from 1805 to 1821 Bewicke Ave. The crest of the ravine slopes is adjacent to the fence on the left side of the picture.

A significant volume of fill material was placed on the slopes to the west of the houses that extend from 1805 to 1821 Bewicke Avenue to level the yards. Tension cracks and significant slumping was noted in this fill (refer to Plate 5), which extends 5 to 6 m back from the slope crest to within about 6 m of the houses. The vertical displacement in the fill ranges between 150 and 300 mm while lateral movement has created bulges in this slope. A comment from one of the homeowners indicates that the fill may contain some sawdust, wood chips or other organic debris.
