Mosquito Creek Ravine East Bank Assessment

City of North Vancouver
141 14th Street
North Vancouver
B.C. V7M 1H9

Wednesday, July 19, 2006
Project #: 005-051

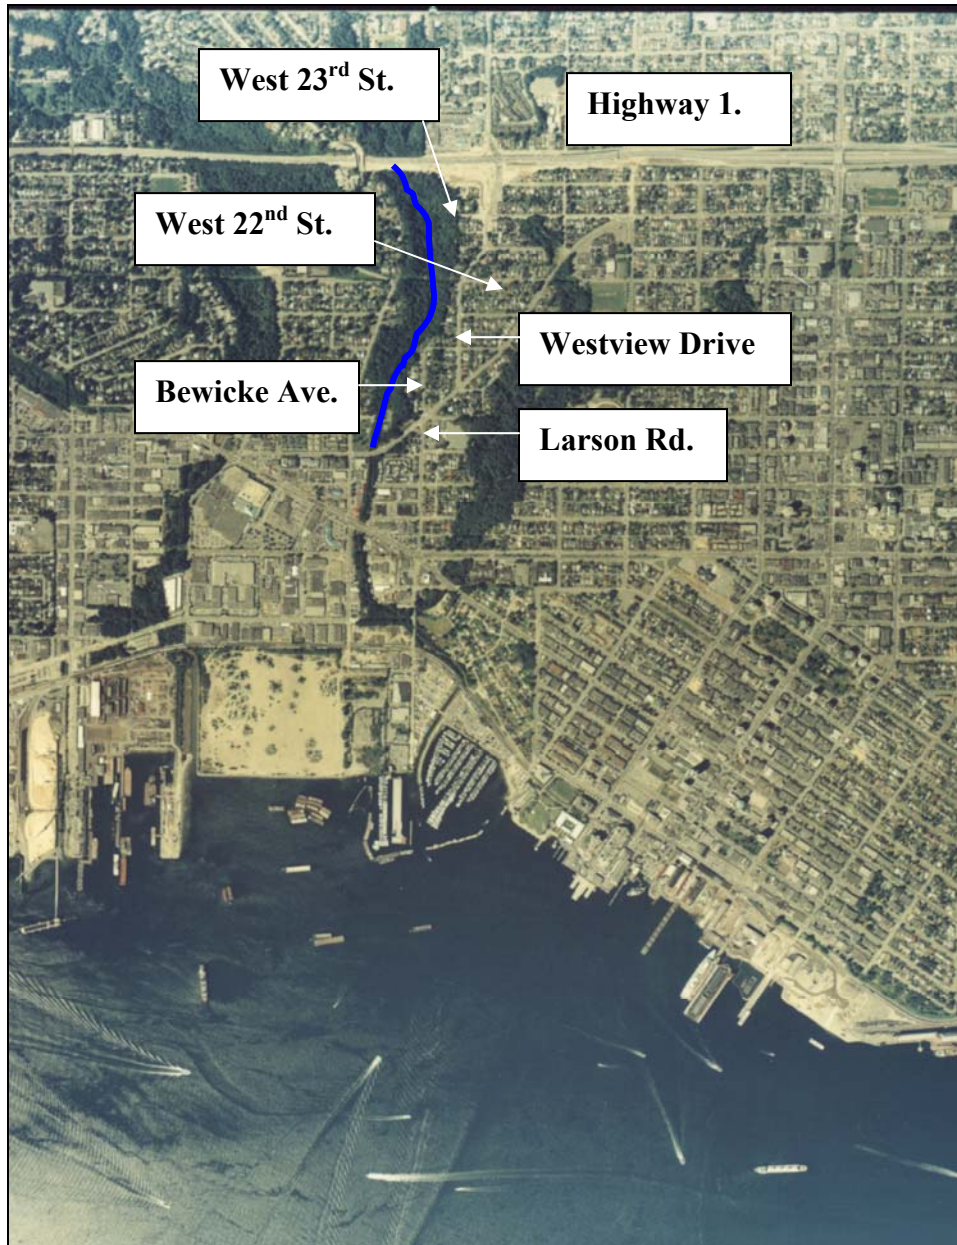
Plate 1: The approximate location of the study area depicted on the 1996 air photo. The approximate extent of the study reach of Mosquito Creek is depicted by the blue line. North is to the top of the page.
